# Gold-Indium Intermetallic Compounds: Properties and Growth Rates

Jane E. Jellison  
Code 313:  
Materials Control and Applications Branch (MC&AB)

Note: Jane Jellison originally composed this as a memo to the TIROS Project to describe her study of failures on gold-ball bonds in detectors made by Honeywell for a TIROS satellite. Henning Leidecker recast her memo into the present article in July 2003.

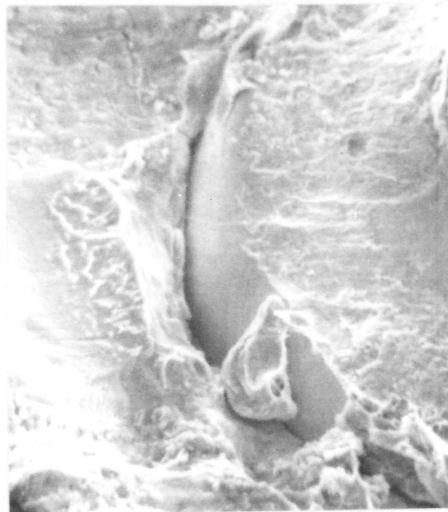
Figure 2: Bond 1-A before (left) and after (right) exposure to 73 hours at 140°C and 97 hours at 120°C. Surface of gold ball is covered with crystalline growth.

The first reaction product was noticed almost immediately after the test was started. Within one hour, the gold wires near the indium contact areas were covered with a surface film which extended up the wire away from the gold-indium interface. This material continued to grow in extent and in thickness throughout the test.

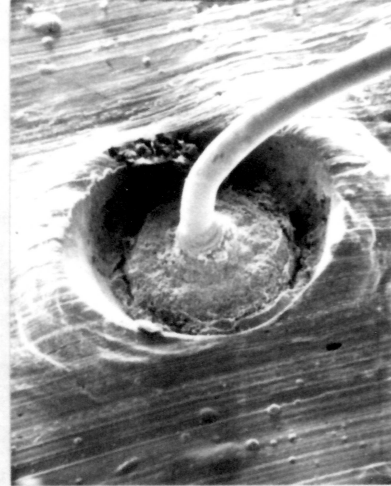
Figure 6: Bond 1D before and after exposure to 140°C. Extensive coverage of gold ball by crystalline growth.

Similar photographs of bond pair 1C-D are presented in Figures 5 through 7. Bond 1C shows a coating of intermetallic compound which approximately doubles the apparent diameter of the wire and which extends several micrometers up the wire, illustrating the mobility of the indium under these conditions. Upon pull testing, Bond 1D lifted at a force of 2.0 g<sub>f</sub>. The whole surface of the gold ball showed extensive compound formation, with small areas of ductile indium fracture surface interspersed with granular intermetallic compound.
